Square Bird Detent Installation

Instructions & photos by Alexander Sosiak with additions by Bill GWP.

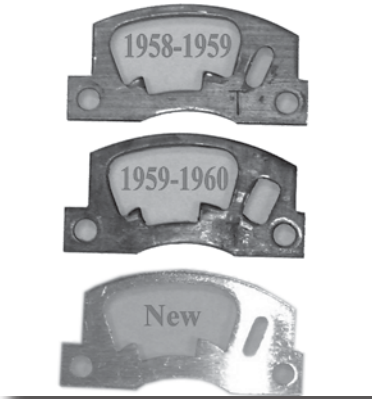
electrical-discharge-cutting, not stamped out like the original Ford part. I also made them out of better steel - low carbon mill steel.

This is a picture comparing the original parts with my redesigned part:

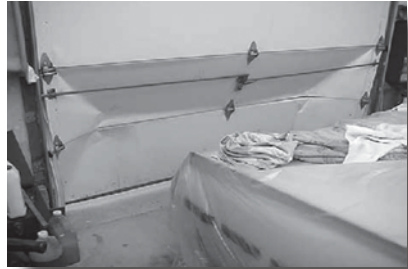
plate, a close friend of mine, Keith Piacente, called me up to tell me that his 1962 Thunderbird Hardtop had gone through his garage door because it had gone into reverse on it own while it was idling in park. Luckily no one was injured and the garage door, not the car, was damaged.

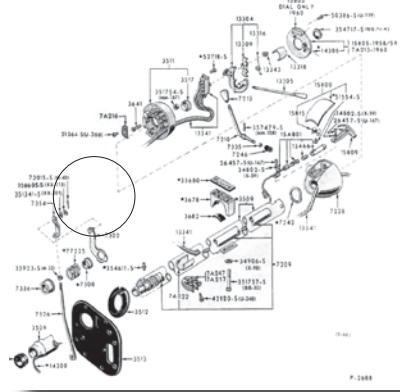
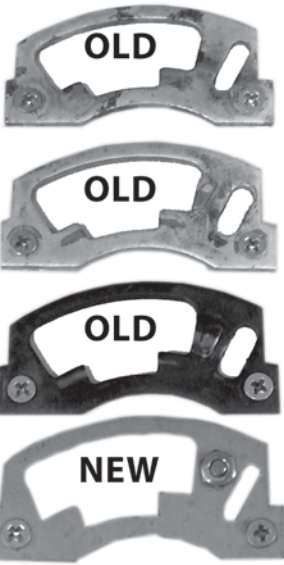
Below, is shown where the 7A216 detent plate sits in the steering column for a 1958-60 Thunderbird. 1961-63 Thunderbird is similar.

It is recommended that the socket assembly (steering collar) for the gearshift lever (part number B8S 7228) and the gear shift lever (part number B8S 7210) and bushings (parts numbers B8S 7246-A and B8S 7335) also be replaced to restore the shifting action to like new. If the end of your gearshift lever is worn or the hole for the roll pin on your gearshift collar is enlarged or oblong this detent part alone will not cure your sloppy gear shifting. The shift collar and gearshift lever can be bought in reproduction from many of the vendors that advertise with the *VTCL*. The B8S 7246-A usually comes with the shift handle.

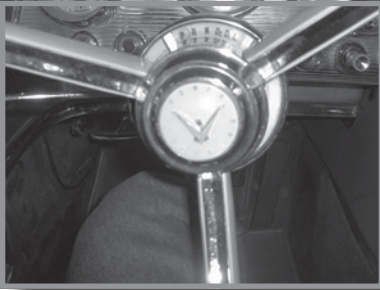
This is your starting point. Make sure your parking brake is on and your wheels are chocked, as you will be removing the device that keeps your car in park.

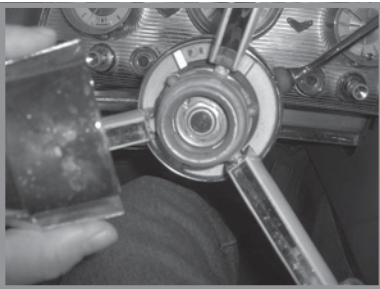
Pull off the center of the steering wheel.

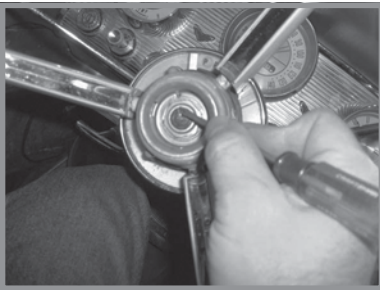
Scribe with a screwdriver or awl a mark towards the hole on the deep dish washer, so you will know in what position to reinstall the steering wheel.

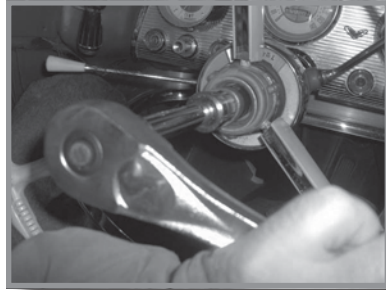
Remove the center nut using a 15/16 inch deep drive socket.

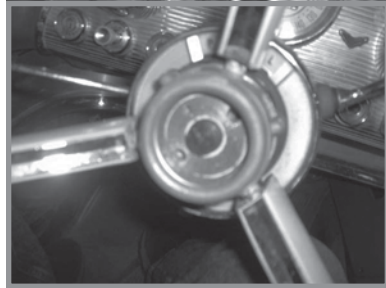
Upon removing the nut and the deep dish washer you will find two threaded holes on either side of the center threaded rod.

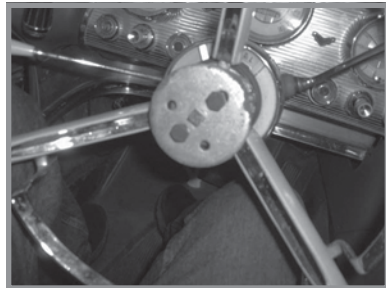
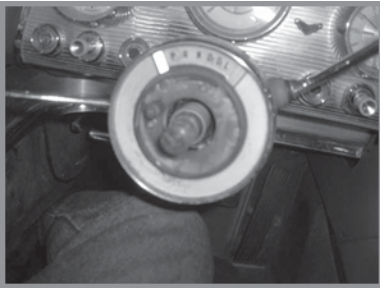
Thread the bolts of a steering wheel puller into the threaded holes. Use the correct bolts. Turn the center bolt of the puller to pop the steering wheel off. Remove the spring under the steering wheel.

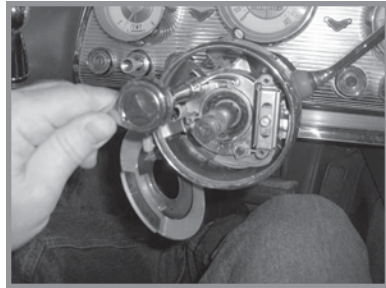
Remove the screws at 9 o' clock and 1 o' clock holding the plastic shift indicator. Lift off the plastic piece from the bottom.

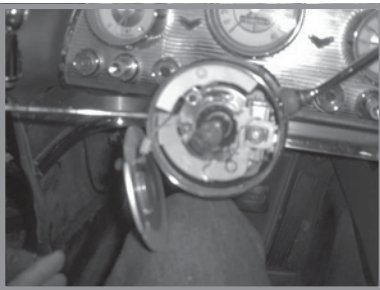
Remove the nuts at 11 o' clock and 5 o'clock. Unscrew the turn signal electrical switch.

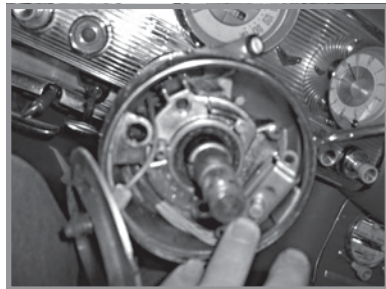
The plastic shift indicator will remain attached by the horn wire. Unscrew and remove the turn signal lever. Remove the spring on the turn signal switch with a small screwdriver. Keep one finder over the spring to prevent it from becoming a projectile. Pull out the plate assembly for the turn signal switch (It connects the turn signal lever to the turn signal electrical switch

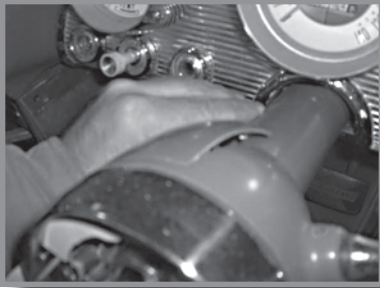
Loosen and remove the center bushing by wedging and spreading the slot on the bushing. It should take minimal force. It has a radial slot. Place a screw driver in the slot and tap on the handle end of the screw driver with you hand so as to rotate it. It just slides onto the steering wheel shaft. After is freed up and can rotate, place the screw driver under the lip of the bushing and pry it up a little. At this point, the bushing can be seen and delineated from the other parts. Now just slide the bushing up the steering wheel shaft by hand until it comes off.

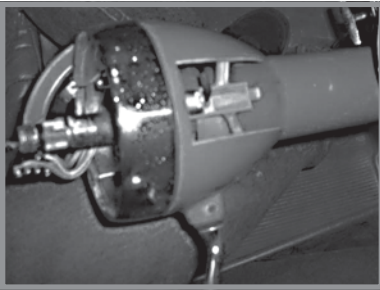
Open up and remove the shift indicator light access plate.

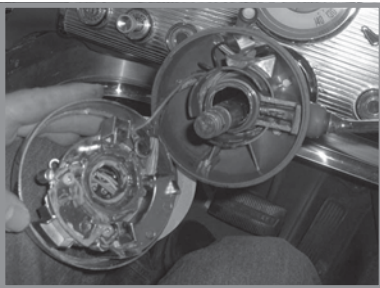
Unscrew the shift indicator light and move it out of the way. Remove the second screw which holds down the white shift indicator plate. Remove the shift indicator plate. Be careful not to let these screws drop into the shift column.

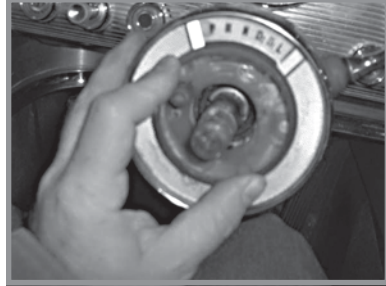
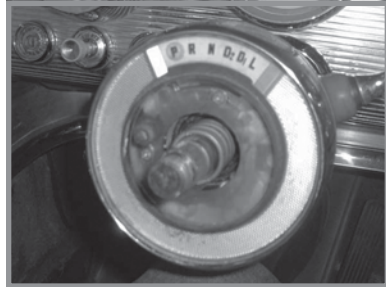
Pull forward the chrome shift indicator flange. Be careful not to lose the two square head bolts

which held down the chrome shift flange. The detent plate is seen here on the chrome flange plate at 7 o'clock. Remove the two screws holding down the detent plate and remove the detent plate.

Reinstall the pieces in the reverse order. One tip on reinstallation: put in the square head bolts into the chrome shift flange and then thread on the nuts a few threads. This will help prevent you from losing your mind when the bolts fall off into the shift column.

The two bolts with square heads at the 11 a.m. and 5 p.m. position: They hold the flange to the column. When reinstalling the chrome bezel (which has the detent plate on the back), the two square heads need to go into the two square slots in the steering

column tube at the 11am and 5pm position. When the chrome bezel is in place and the two bolts have the nuts run on them only about the thickness of the nuts, hold and wiggle the bolts as you tighten them so that the square bolt heads go into the slots. The bezel has stops that prevent the bolts from turning. As you tighten up the two nuts, the chrome bezel will tighten up against hemispherical shaped part of the steering column by sucking down the bezel to the steering column/square slots. The two bolts hold everything tight. If they are not secured in the two slots, everything will be loose and the shift lever will no go into the detents. And you cannot see if they are in the slots, you just have to feel it by the successful tightening of the assembly as you turn the nuts. It might be easier to have the shift lever in the large neutral slot for the bezel re-installation rather than the very small slot in the detent for Park as you try to tighten and hold everything at the same time.

While everything is apart, lubricate the bearing on the flange with bearing grease and put some lubricant on the detent plate. Remember to reinstall all the parts including the spring under the steering wheel. Torque down the steering wheel center nut to 40-60 foot-pounds.
